# FINAL REPORT for TESTS ABLE and BAKER

BUREAU OF AERONAUTICS  
GROUP

DIRECTOR OF SHIP MATERIAL  
JOINT TASK FORCE ONE

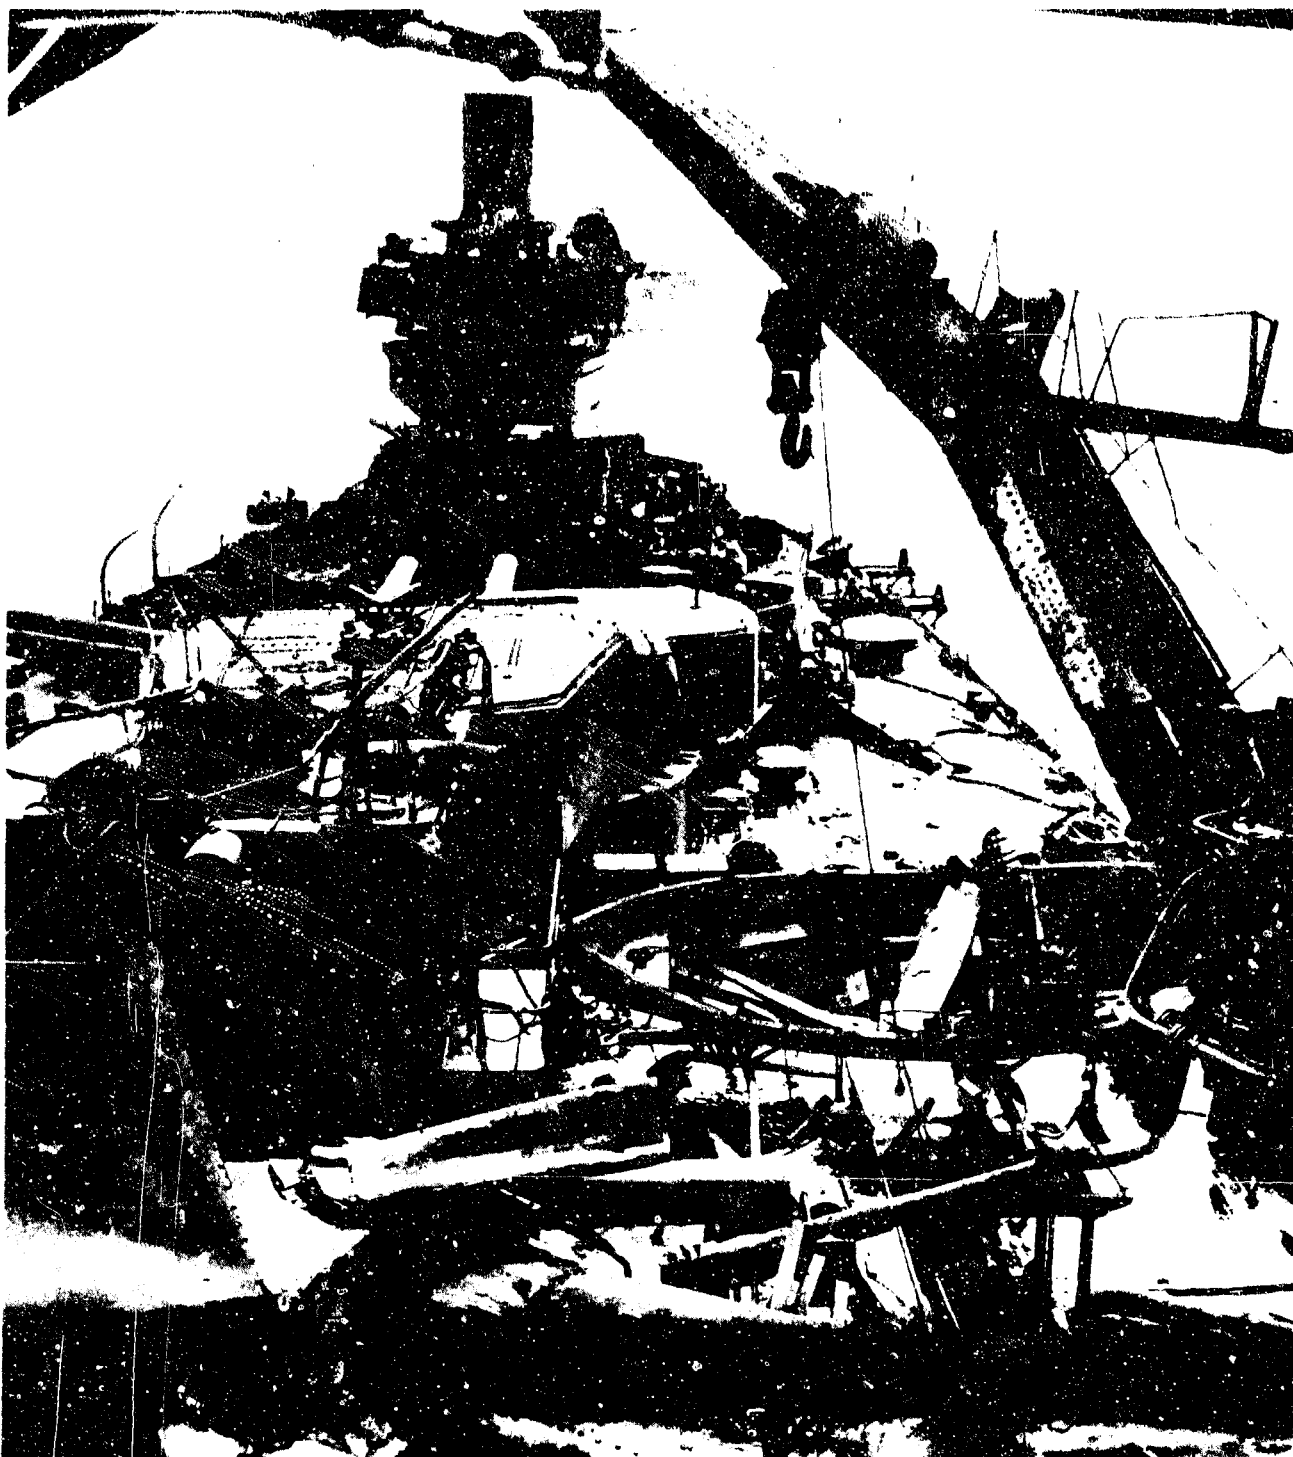
General view of USS ARKANSAS after Test ABLE. OS2U-3 secured to cradle welded atop the turret, visible to the left of center in photograph, was blown over the side with no trace of the airplane remaining.

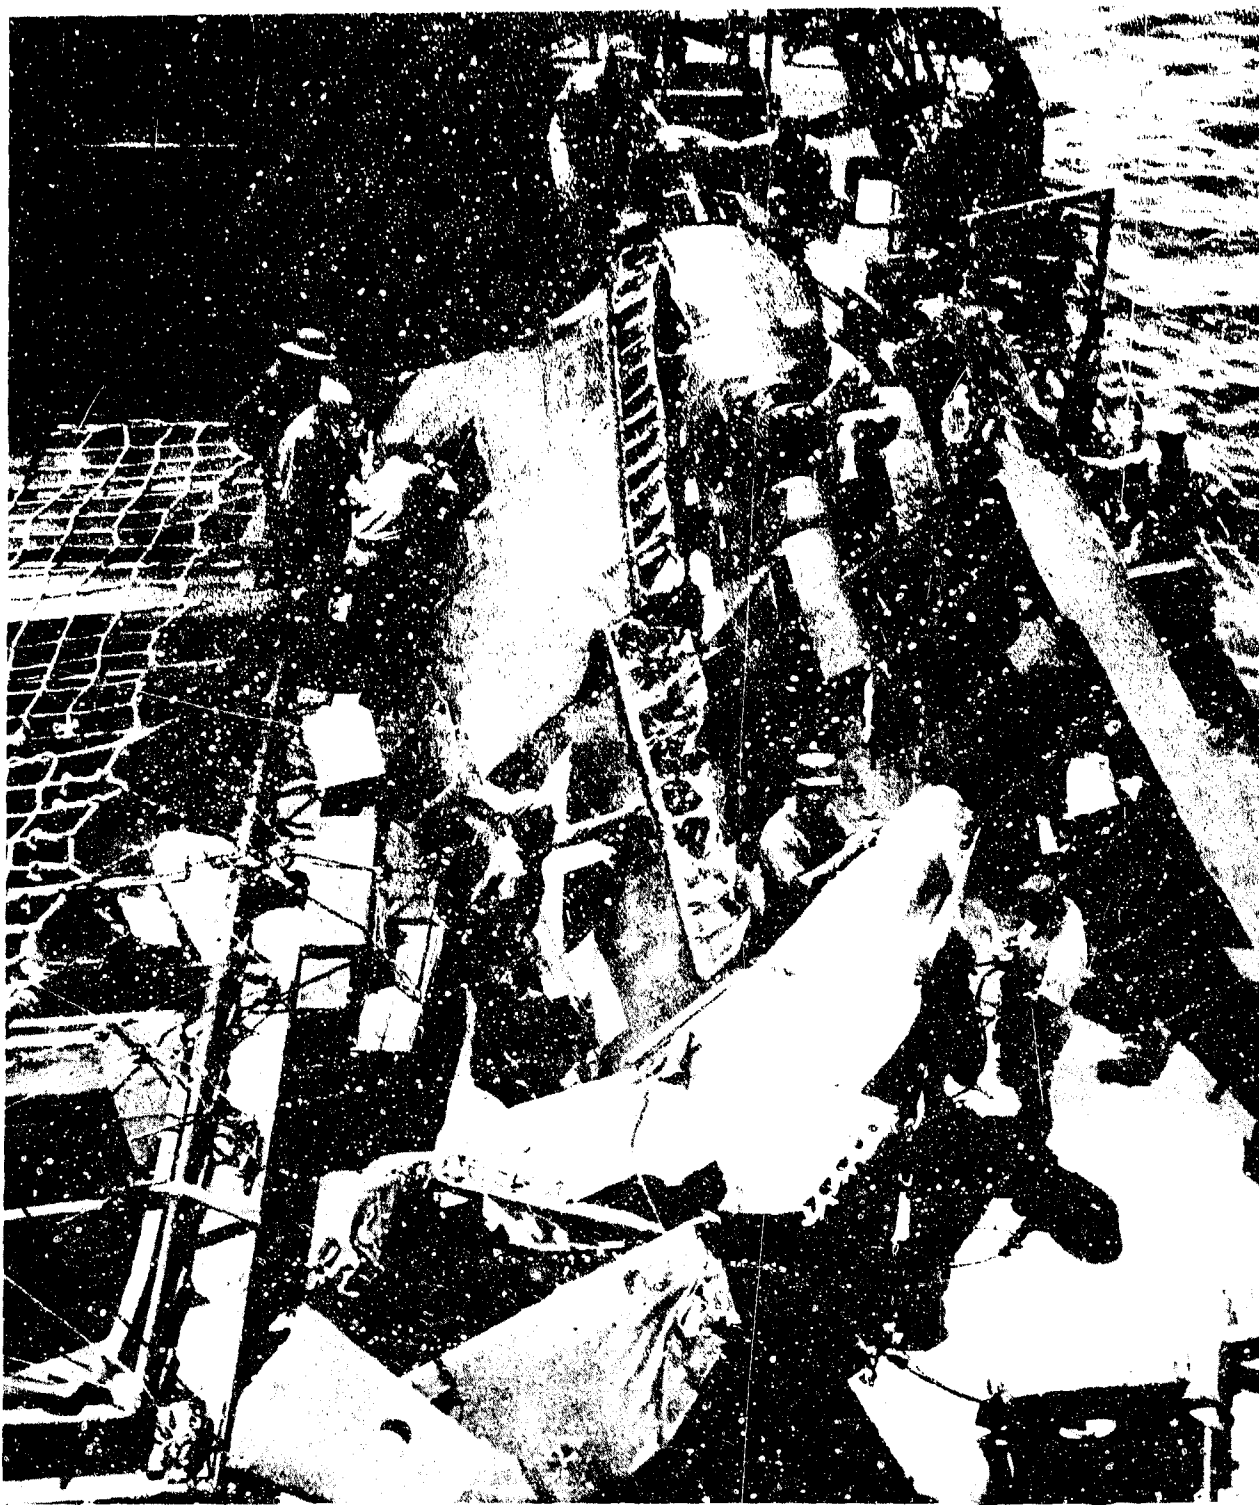
Model F6F-5 Airplane on main deck of USS DAWSON APA-79. This airplane in inner zone illustrates typical severe structural damage from blast effect.

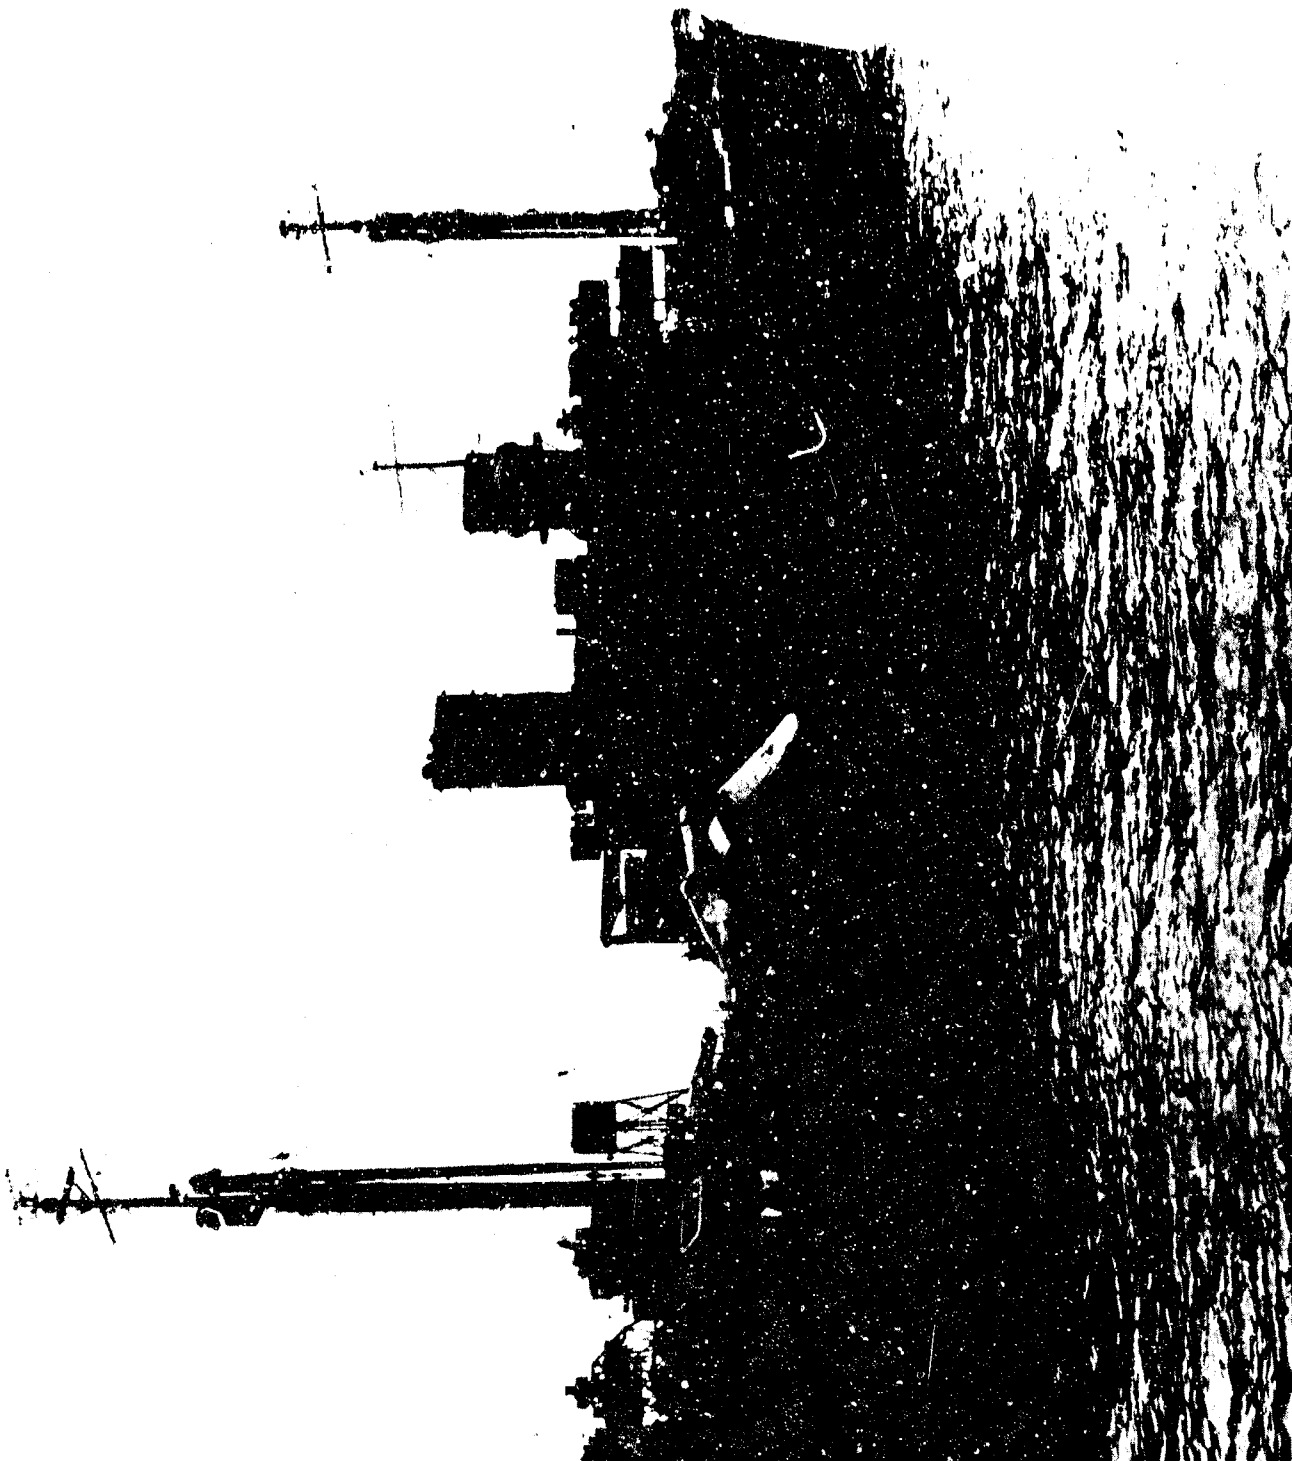
Model FG-1D airplane on main deck of USS CARTERET APA-70, after Test ABLE. The CARTERET was approximately 1600 yards from the blast center in the intermediate zone of damage. Right wing was blown from folded position by the blast.

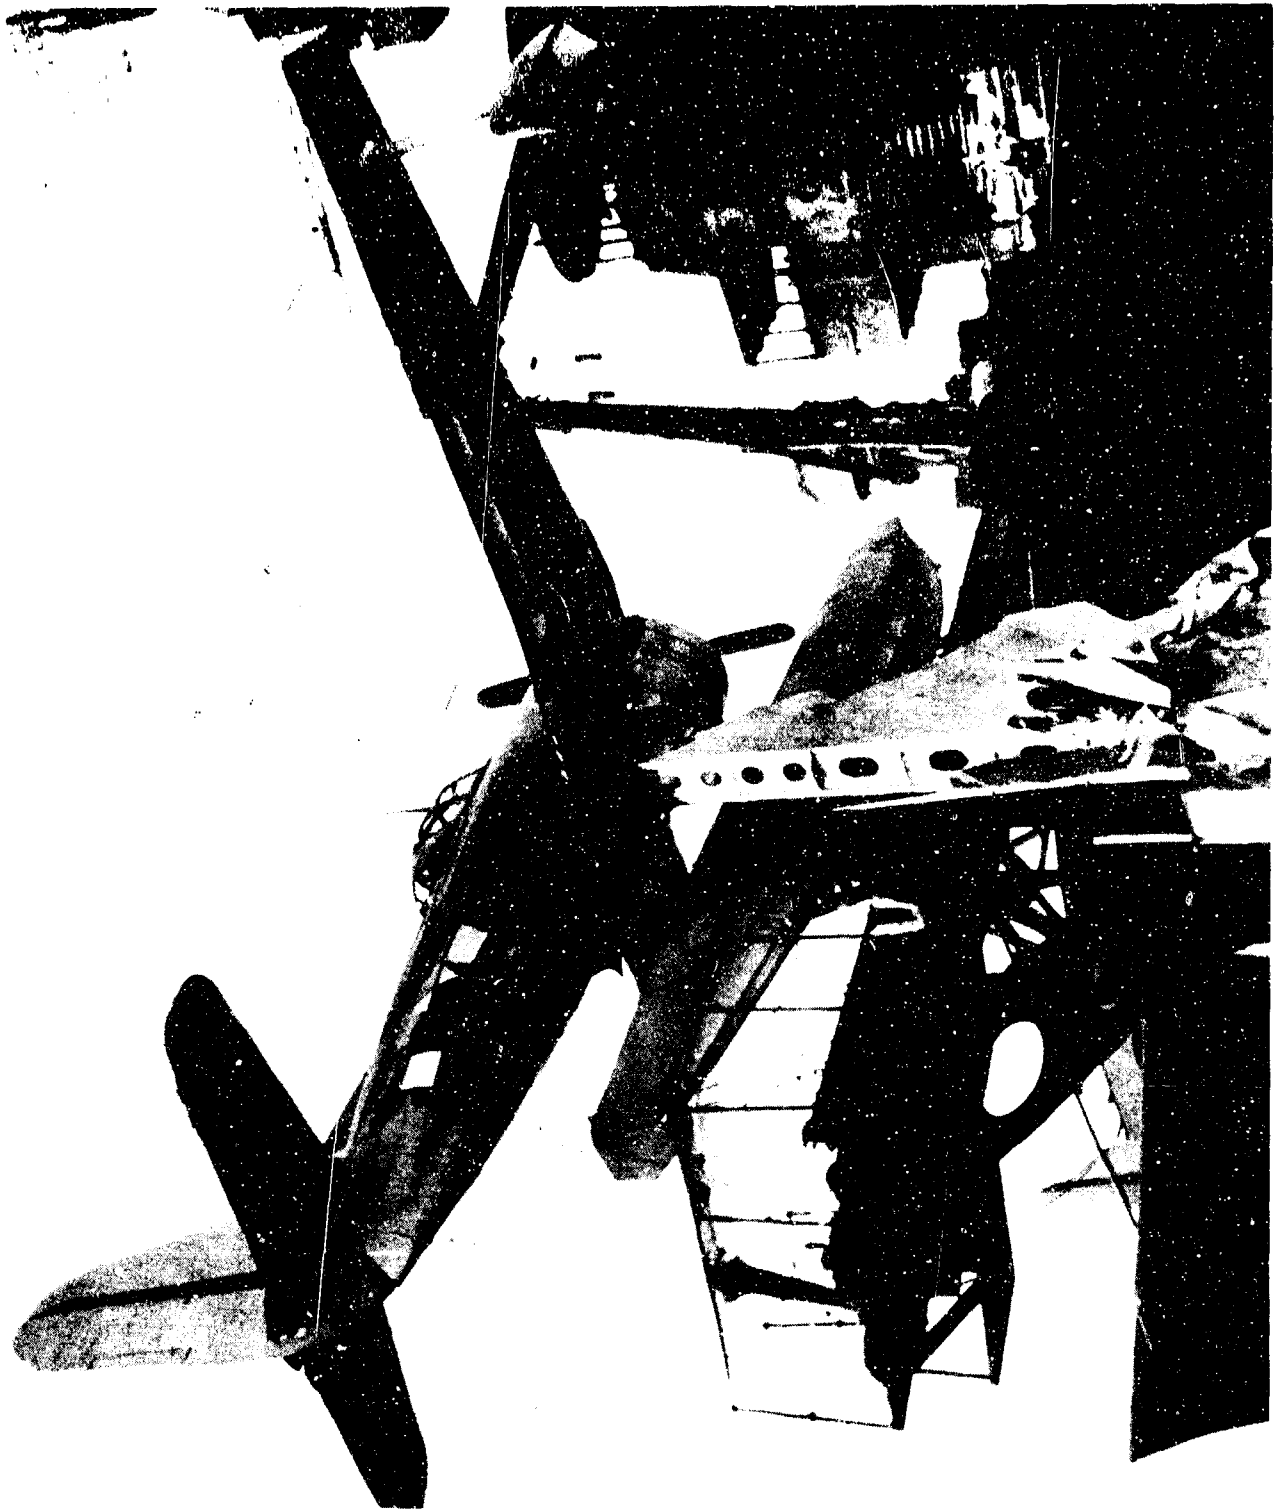
Model XSC-1 Airplane in place on catapult on USS NEW YORK after Test ABLE. This airplane in the intermediate zone shows extreme buckling of fuselage and loss of control surfaces.

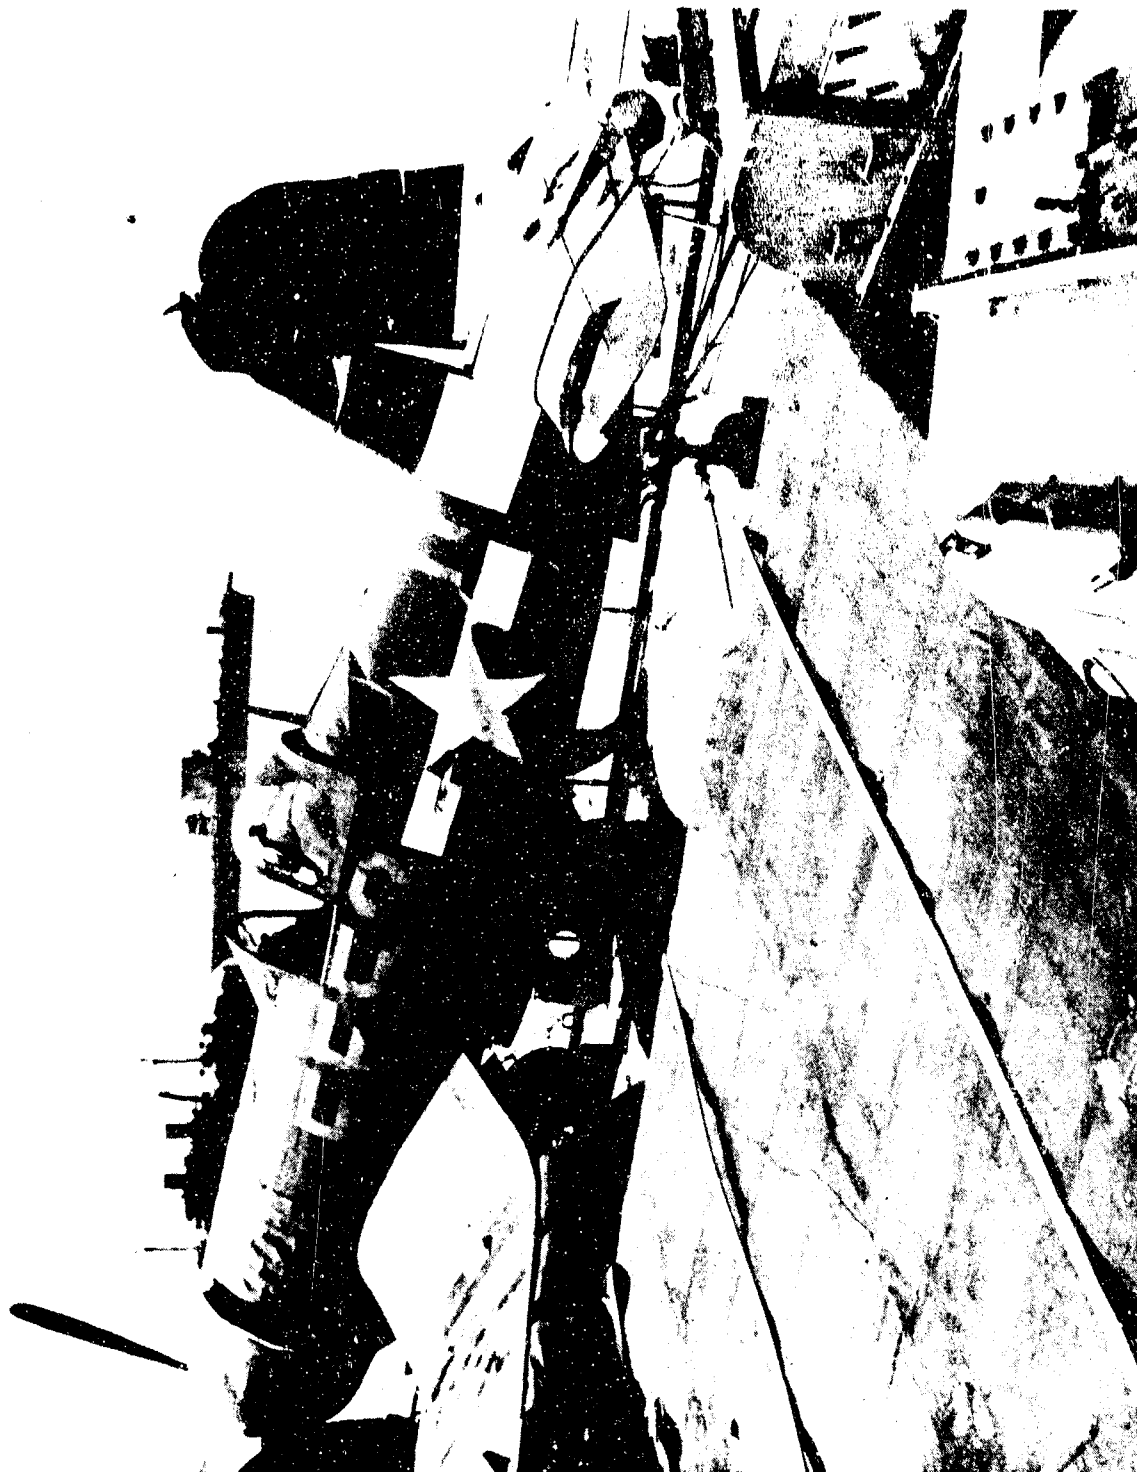
Model FG-1D on main deck of USS FALLON APA-81 after exposure to Able blast. The FALLON was approximately 1300 yards from actual blast center. This airplane sustained damage typical throughout the intermediate zone of 1300 to 2200 yards from the blast center.

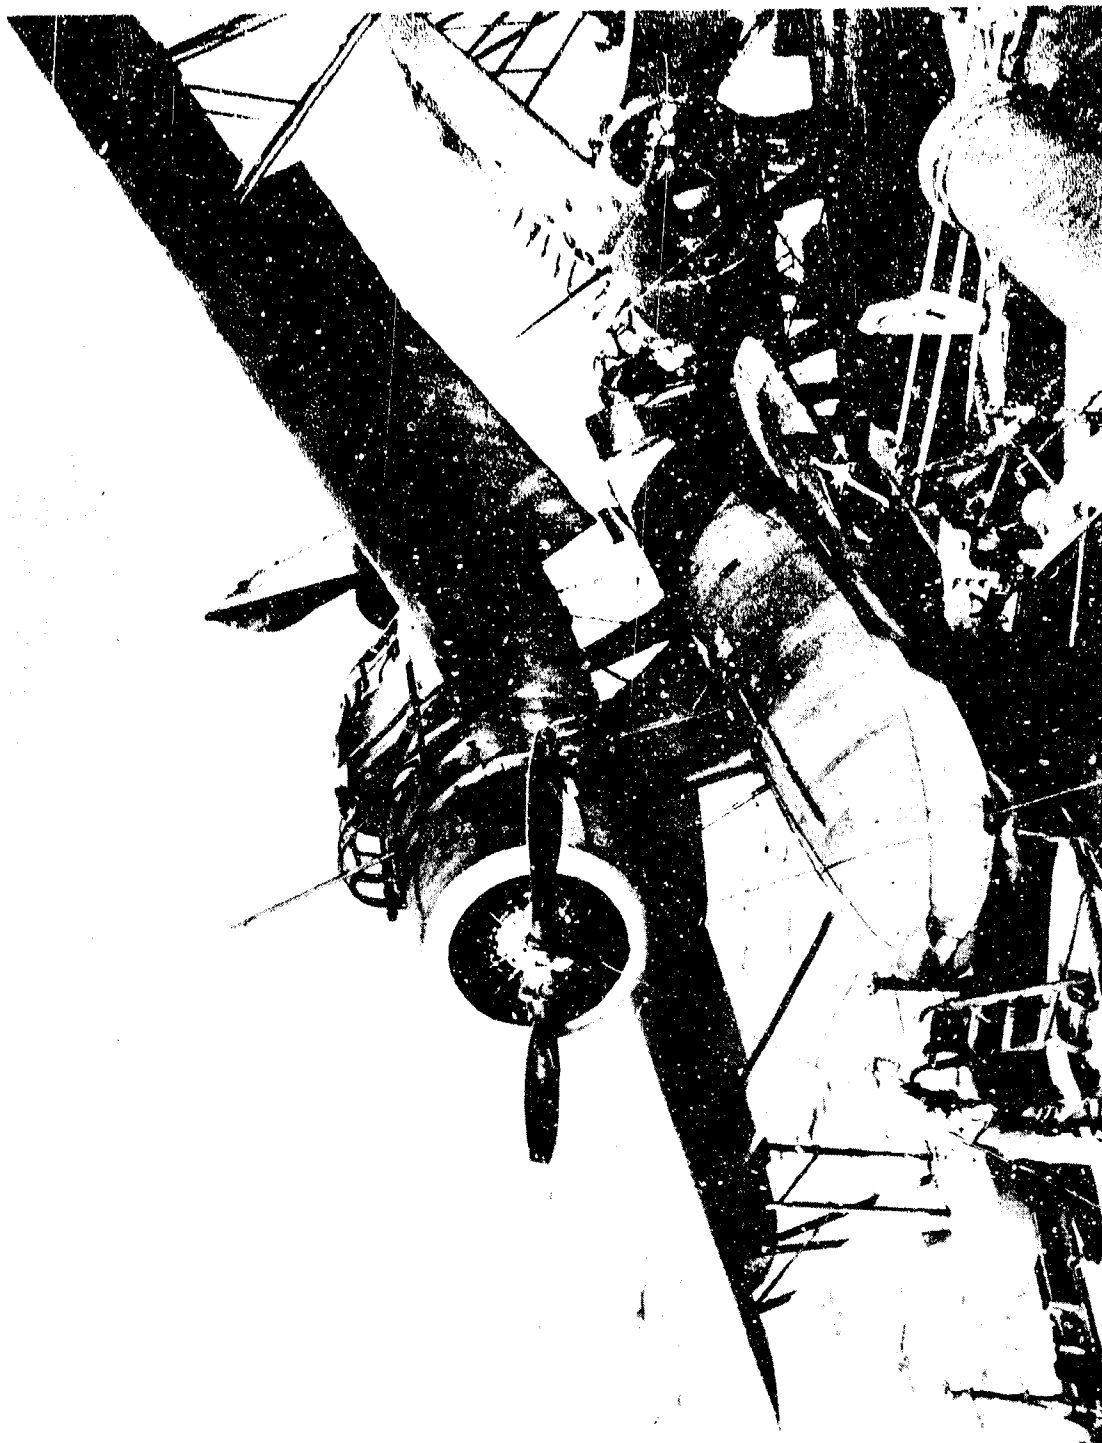
Model OS2U-3 airplane on board USS PENNSYLVANIA after Test ABLE. Float type aircraft exhibited less resistance to overturn as compared to wheel type aircraft, and consequently may be more affected by secondary damage due to falling to deck. Note blast damage to control surfaces and cockpit panels.

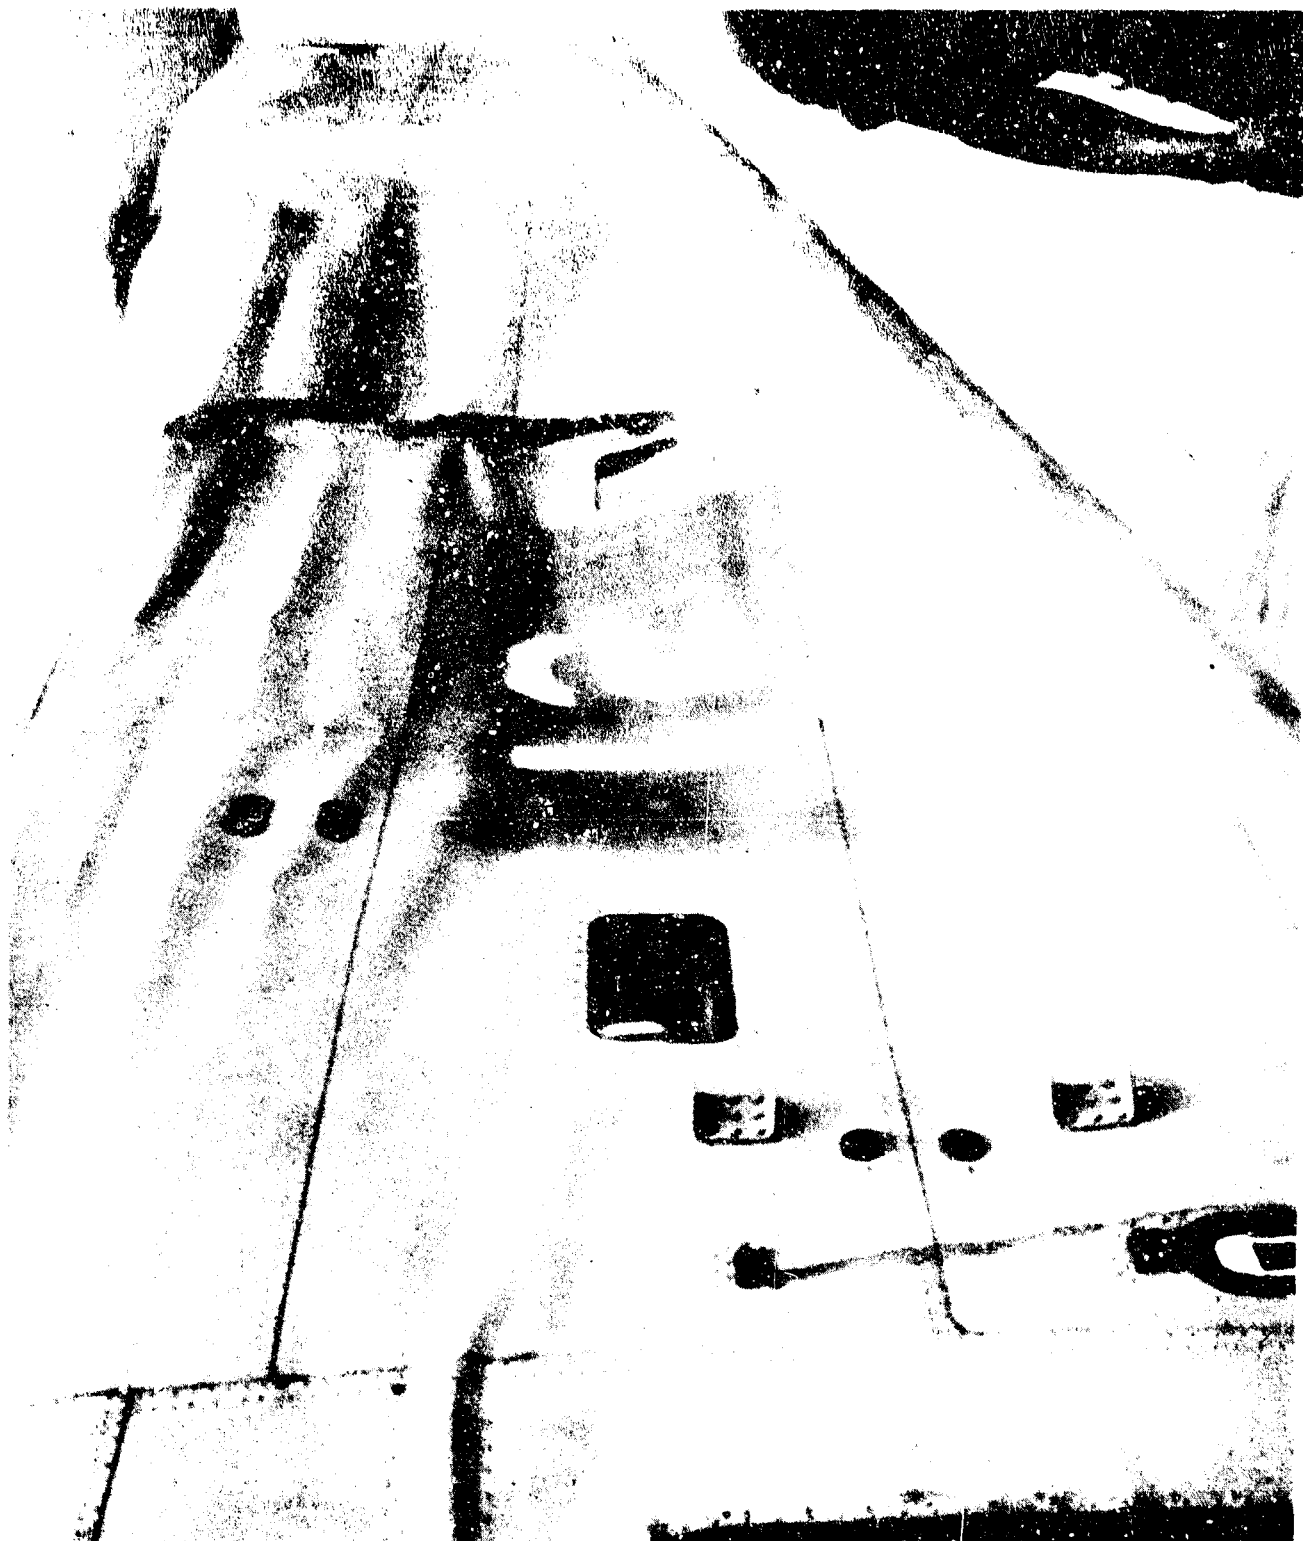
Model PB2Y-5H airplane after Test ABLE moored at 2500 yards from the blast. View shows buckling of the fuselage caused by air blast.

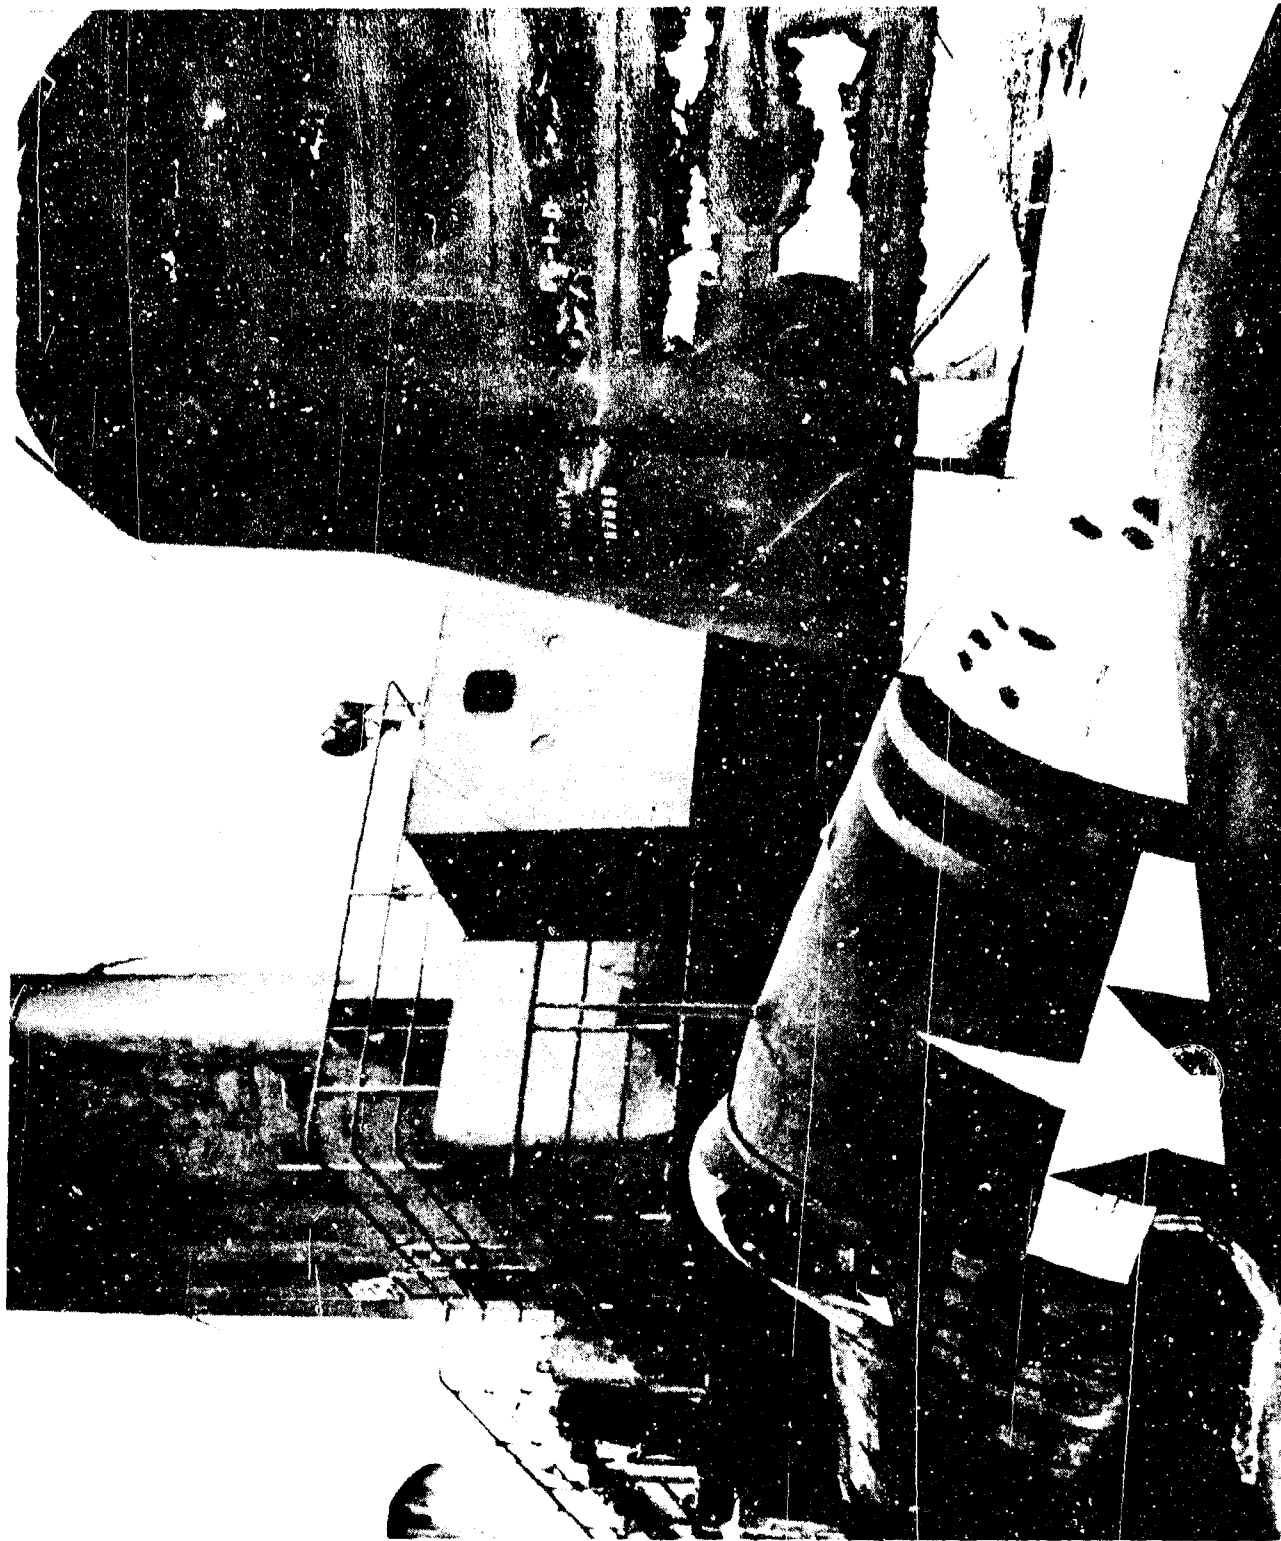
Model FG-1D airplane on main deck of USS BLADEN after Test ABLE. Scorching of fabric and damage to plexiglass is typical of the minor damage sustained by airplanes in the outer zone.

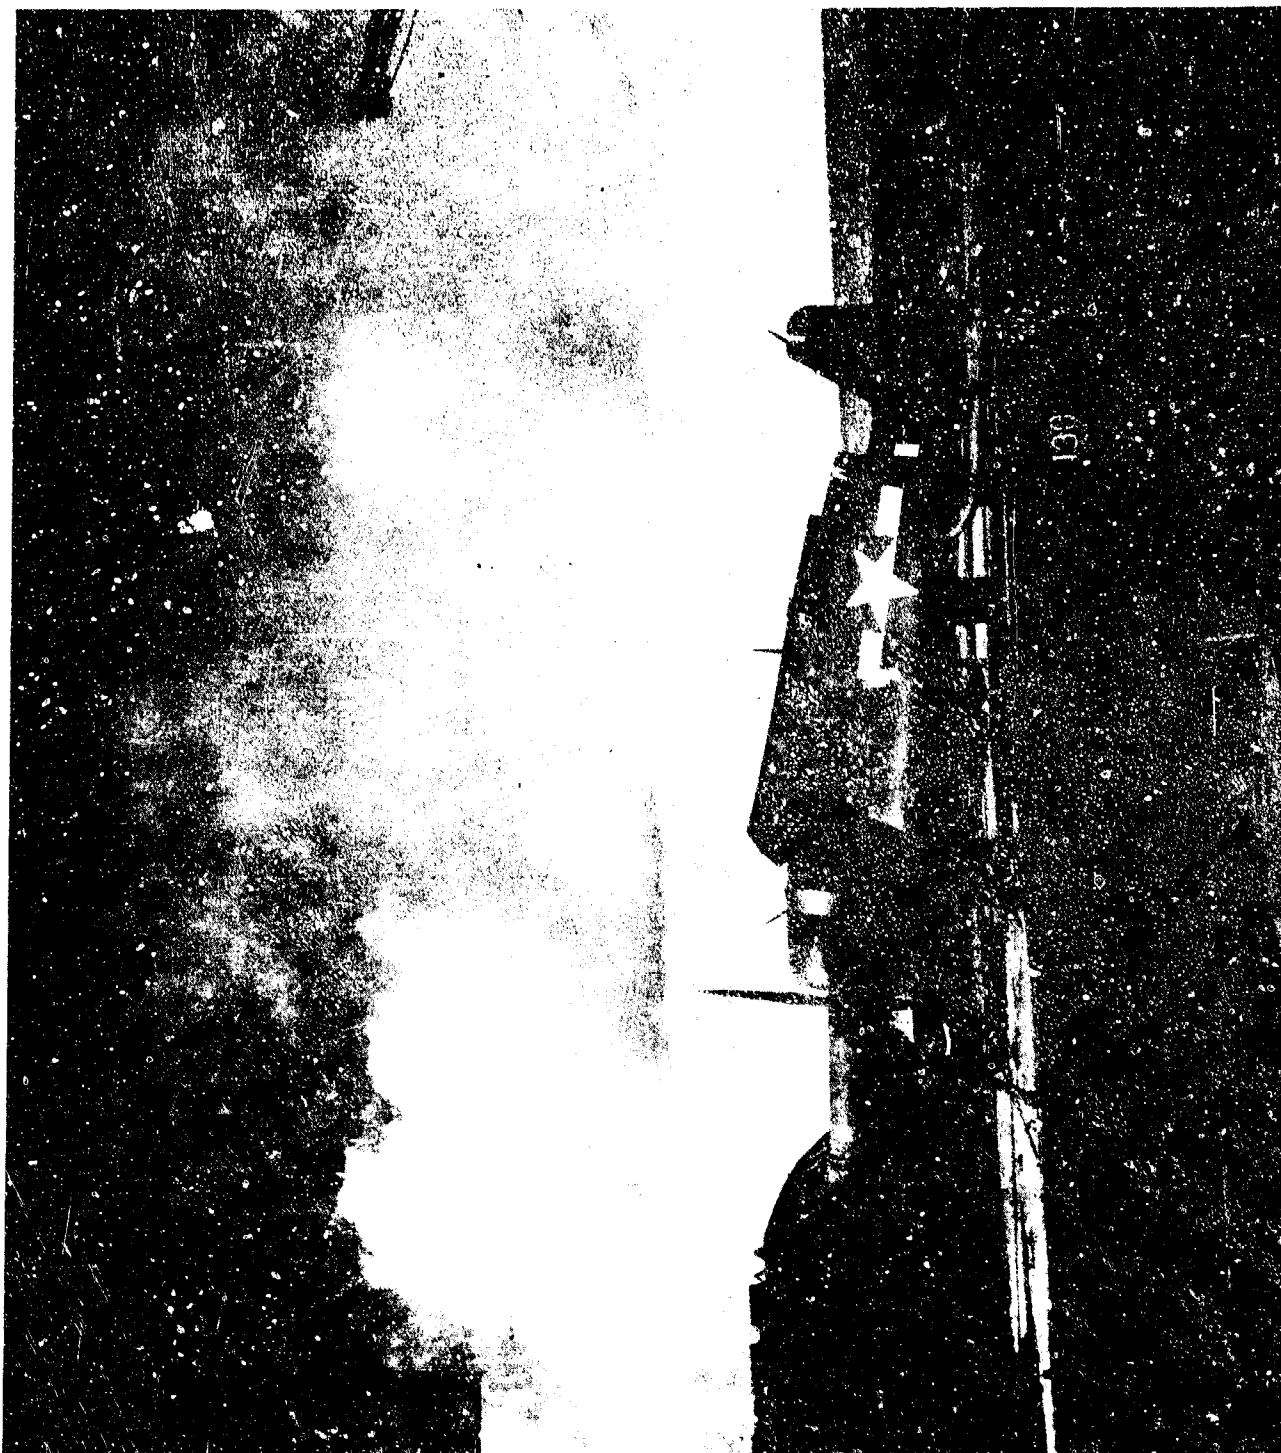
Model F6F-5N airplane aboard PENNSYLVANIA at approximately 1200 yards from burst. This airplane was essentially undamaged by Test BAKER, however extreme radiological contamination would prevent routine maintenance or operation.

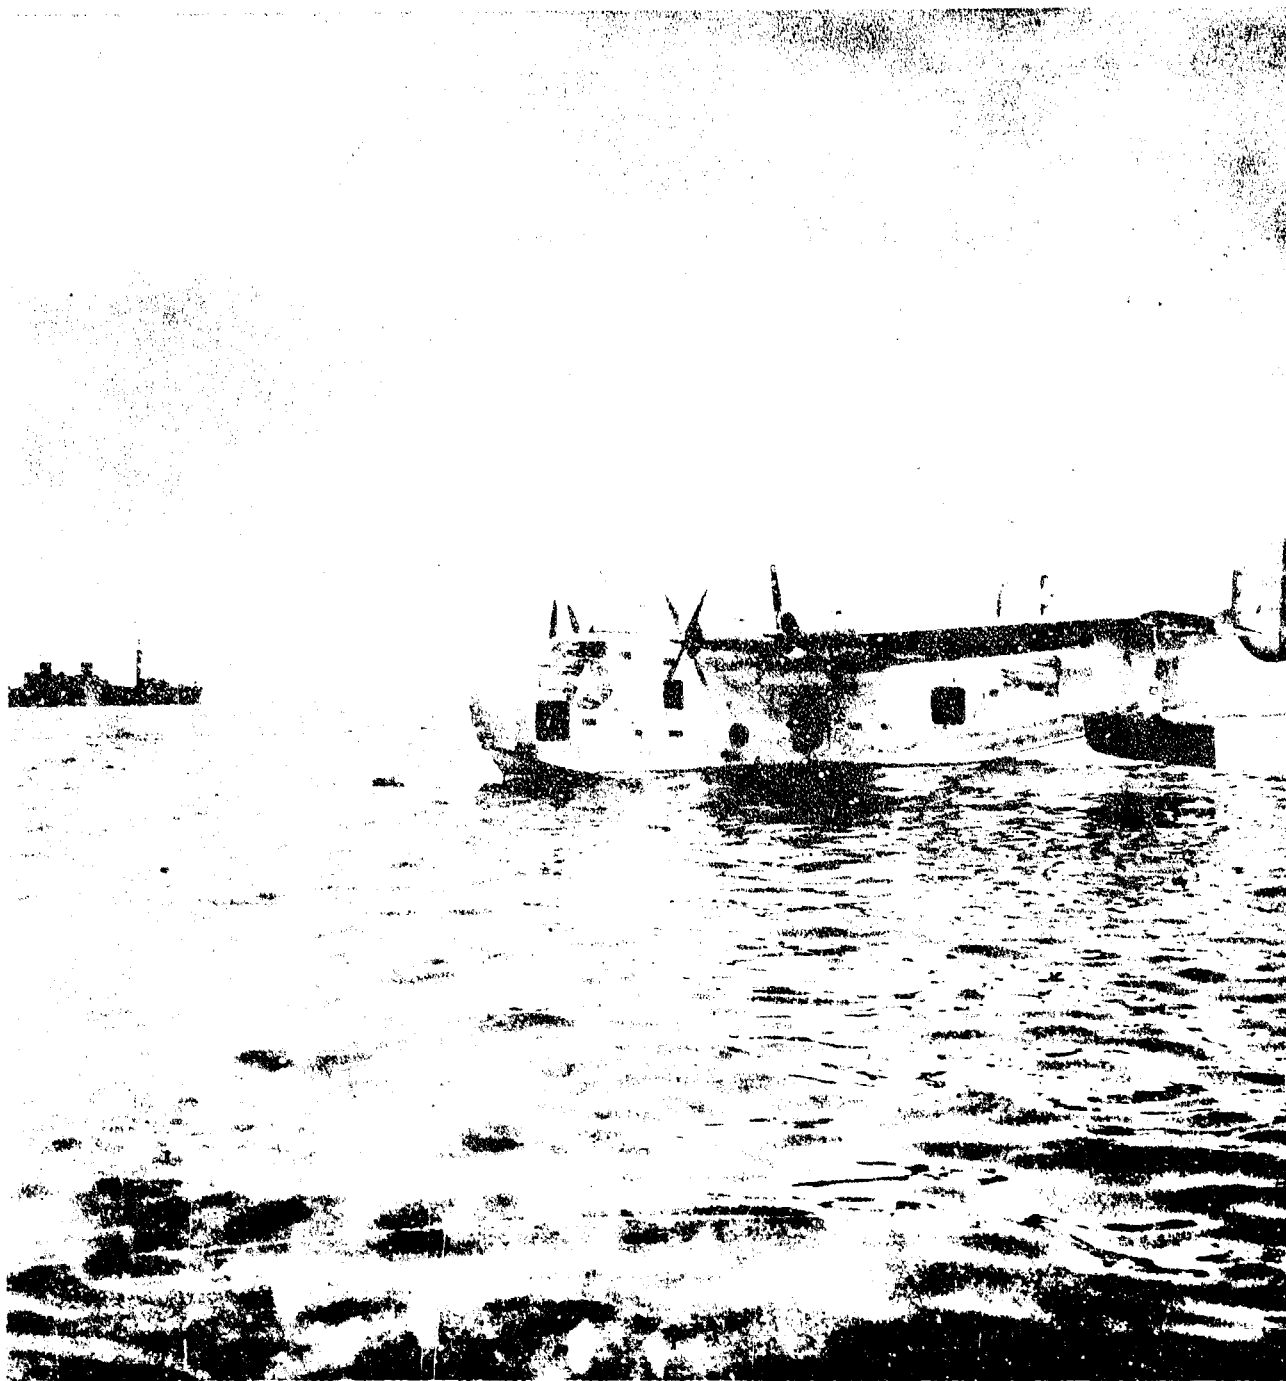
PHOTOGRAPH NUMBER: - AF-615\*97

Model PB2Y-5H Airplane BuNo 7085 moored at approximately 3000 yards from burst. Additional damage sustained in Test BAKER; namely increase in buckling in nose above insignia, and further damage to after portion of fuselage, was caused by air blast effect. Note that temporary hatch covers installed after Test ABLE have been blown in.
